BEFORE AND AFTER ON BARKERS ROAD AROUND TREE LISTED FOR FELLING

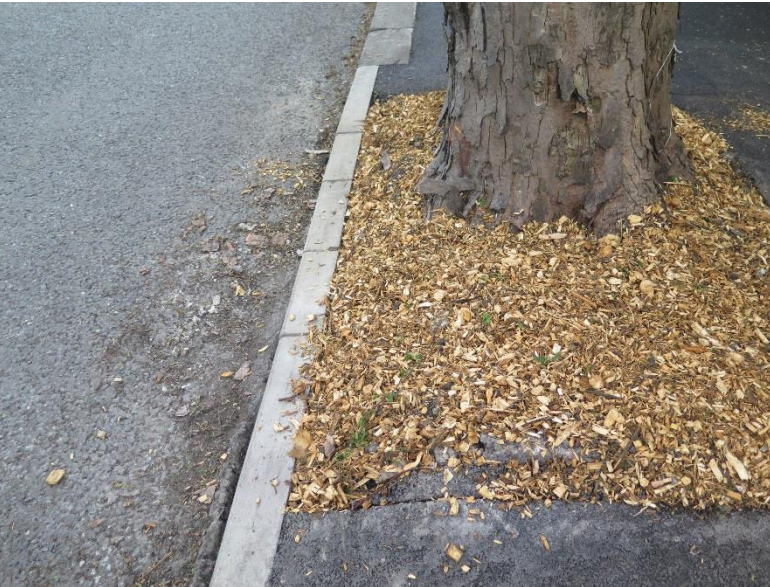
Original Amey assessment: Kerbstone absent, f/w mounded, cannot repair without unacceptable root damage
