BEFORE AND AFTER ON BARKERS ROAD AROUND TREE LISTED FOR FELLING

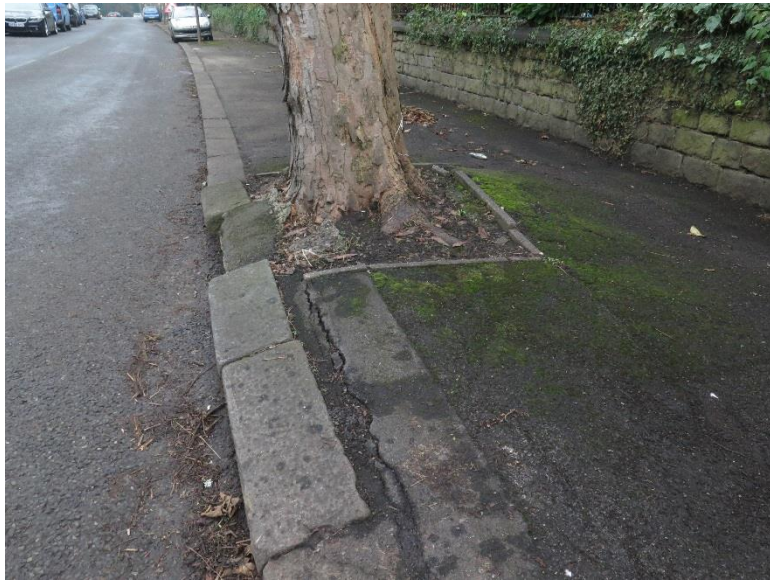
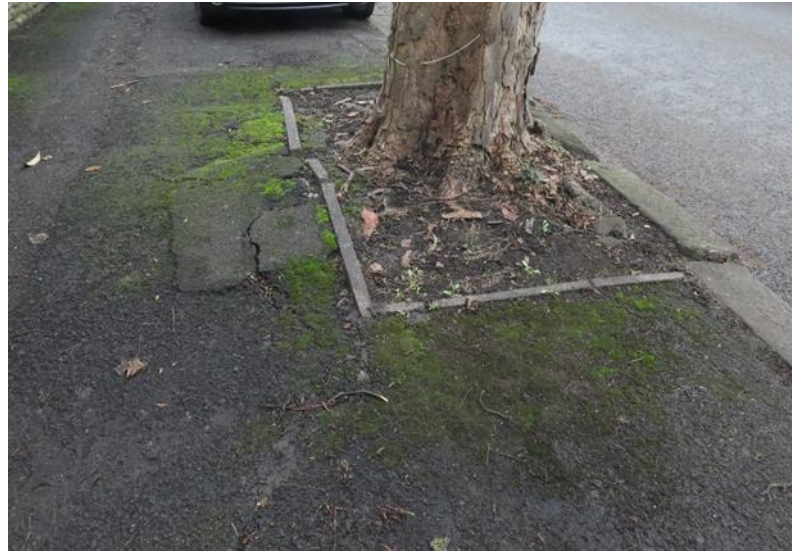
Original Amey assessment: Kerbstone absent, f/w mounded, cannot repair without unacceptable root damage

Pavement repair: Half profile kerb stone used.
